DEPARTMENT OF TRANSPORTATION**DIVISION OF ENGINEERING SERVICES**

Contract #: 04-0120F4Cty: SF/ALA Rte: 80 PM: 13.2/13.9File #: 69.28**WELDING INSPECTION REPORT****Resident Engineer:**Pursell, Gary**Address:** 333 Burma Road**City:** Oakland, CA 94607**Report No:** WIR-001475**Date Inspected:** 15-Feb-2008**Project Name:** SAS Superstructure**OSM Arrival Time:** 800**Prime Contractor:** American Bridge/Fluor Enterprises, a JV**OSM Departure Time:** 1500**Contractor:** Zhenhua Port Machinery Company, Ltd (ZPMC), Changxing Island **Location:** Shanghai China

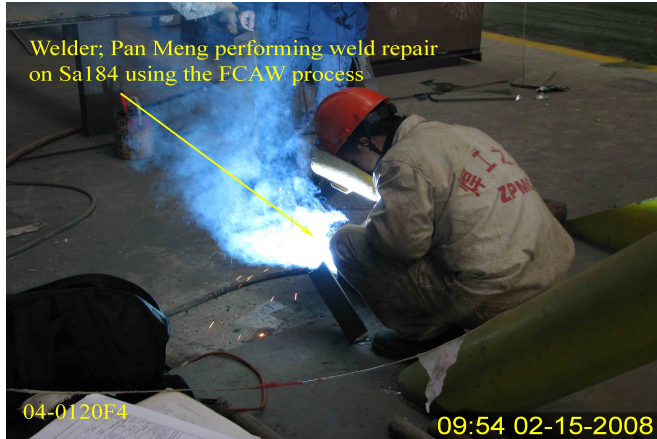
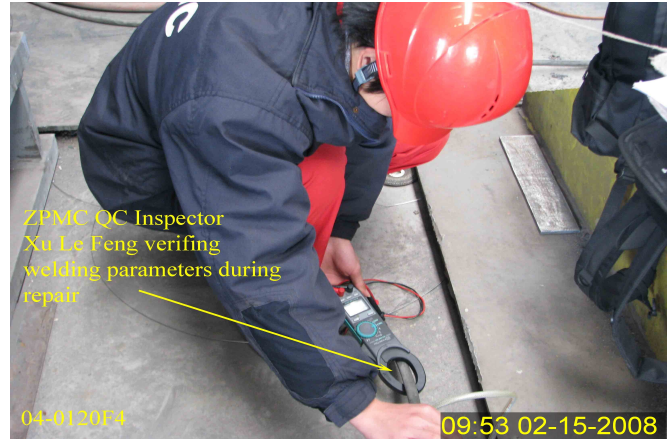
This Quality Assurance (QA) Inspector arrived at ZPMC for observation of the 89m mock-up in the tower shop for corner stiffener plates fitted to skin plates B and C. This QA Inspector observed ZPMC performing a weld repair on plate Sa 184 for the rejectable indication noted in report dated 2-14-08. Welding Procedure Specification (WPS) number; WPS-B-T-2231-B-U2a-F was witnessed as being applied at this location by this QA Inspector. ZPMC Quality Control (QC) inspector Xu Jing Long and Xu Le Feng was observed as being present during the repair process and monitoring the progression and welding parameters. This QA Inspector verified the welding parameters of ZPMC welding personnel Pang Meng as follows; 297 amps, 29.3 volts and travel speed of 300mm/min. The preheat temperature was recorded as minimum 65°C with a maximum of 230°C as required by the WPS. Once the repair was completed ZPMC has allowed the part to cool to ambient temperatures and will perform re-examination with ultrasonic testing the following day. ZPMC personnel proceeded with the fit-up of plate Sa194 to skin plates B & C in accordance with the contract documents for placement. This QA inspector observed ZPMC adjusting the plate with grinding to achieve a proper fit-up and root tolerances ZPMC worked on the fit-up for the remainder of this QA Inspectors shift. The work performed above appeared to be within the general requirements of the contract documents. See digital photos below for ZPMC welding personnel performing weld repair and ZPMC QC personnel monitoring welding parameters.

This QA inspector spoke with ZPMC QC personnel Xu Le Feng in regards to the repair process and was informed that ZPMC would perform a ultrasonic examination on the repair weld tomorrow.
